**REPORT OF INSPECTION
FOR
ASBESTOS-CONTAINING BUILDING MATERIALS
HELENA HOUSING AUTHORITY, STEWART HOUSING COMPLEX
HELENA, MONTANA**

November 5, 2007

WTR Project # 07912-1.1

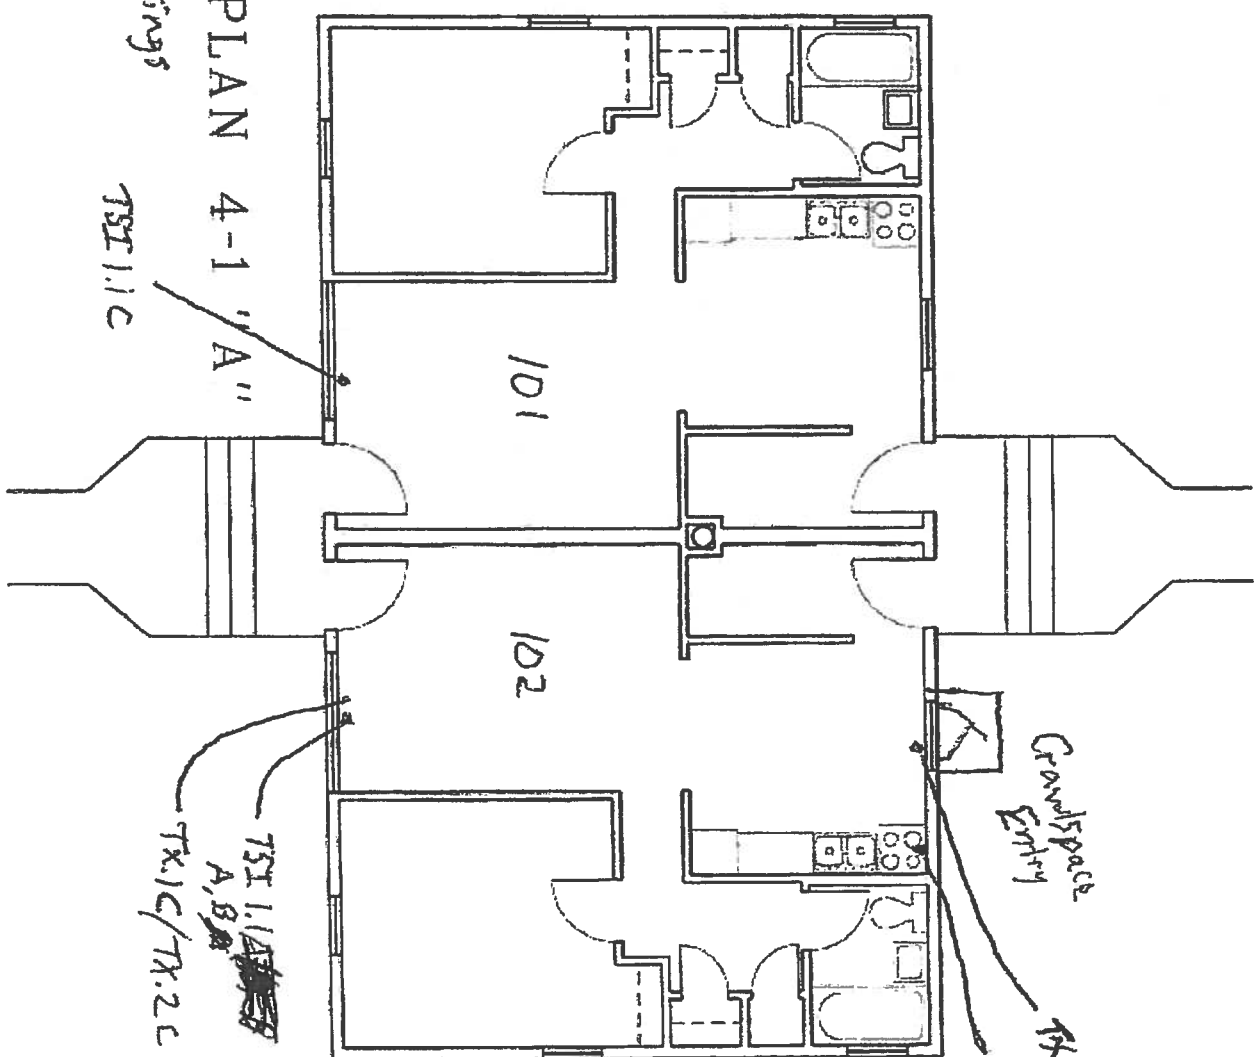
FIRST FLOOR PLAN 4-1 "A"

101, 102 Crawl Space

Qty: 8 TSI Fillings

TSI 1.1C

TSI 1.1A, B, C
TK.1C/TK.2C
